MCR-68-119 Copy No.

STERILIZABLE LIQUID PROPULSION SYSTEM

FINAL REPORT (PART II)

MARTIN MARIETTA CORPORATION

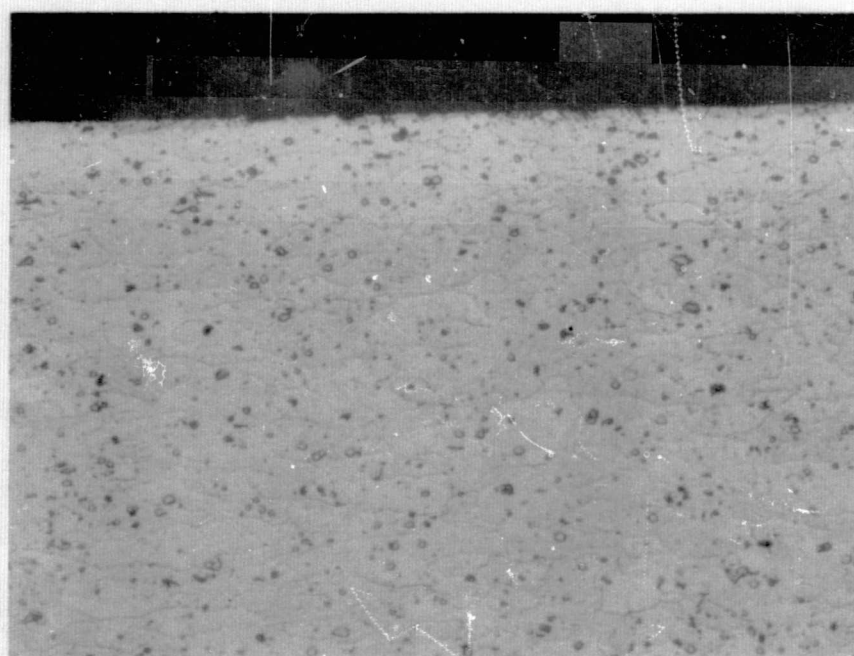
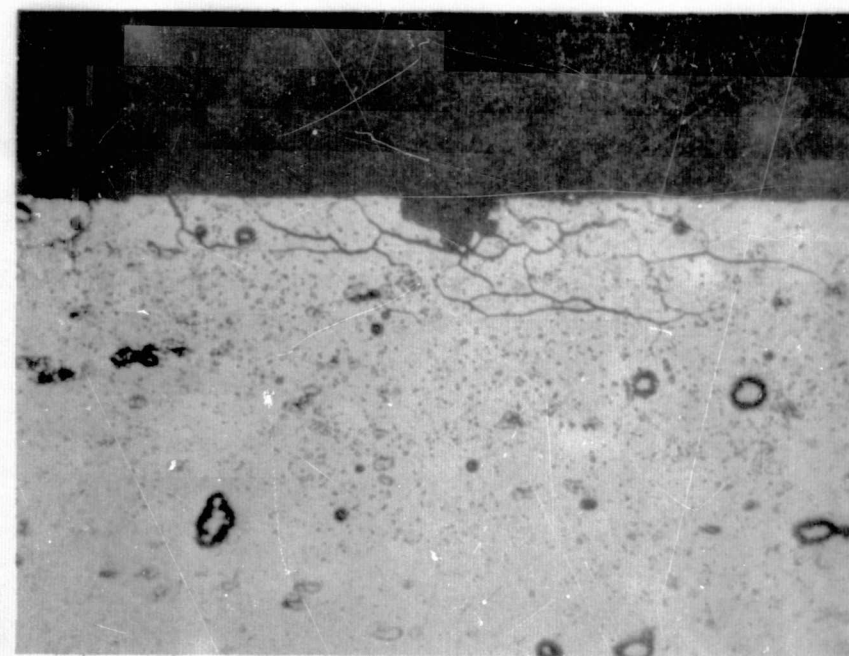
Fig. V-1 Aluminum (2014-T6) after Exposure to N_2O_4 for 600 Hours at 135°C (200x)

Note: No attack is noted on the chromic acid anodized aluminum.

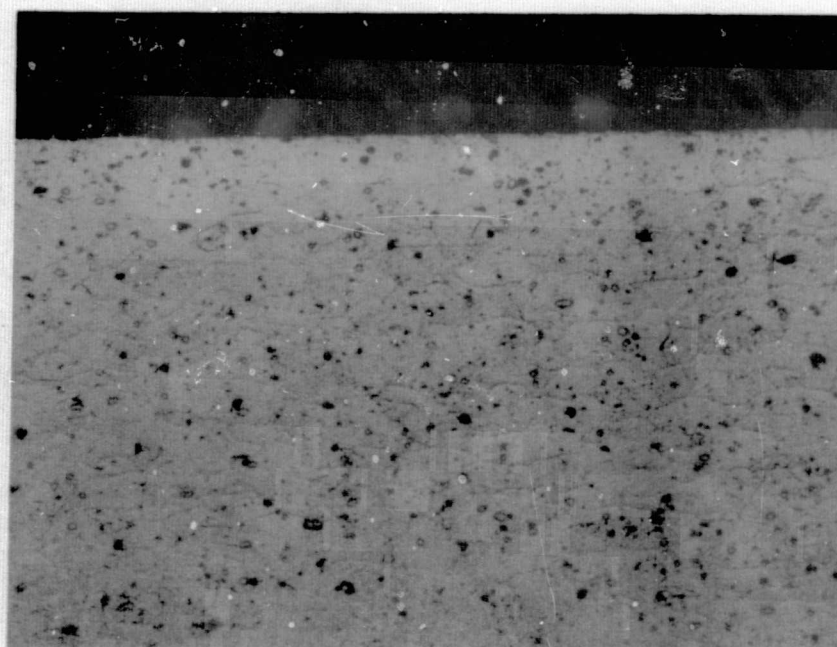
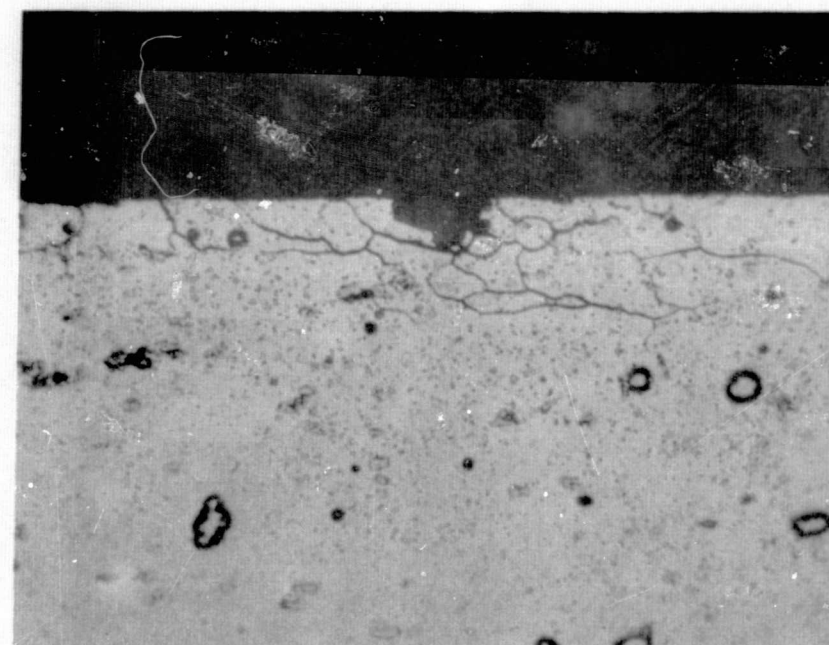
Note: No attack is noted on the sulfuric acid anodized aluminum.

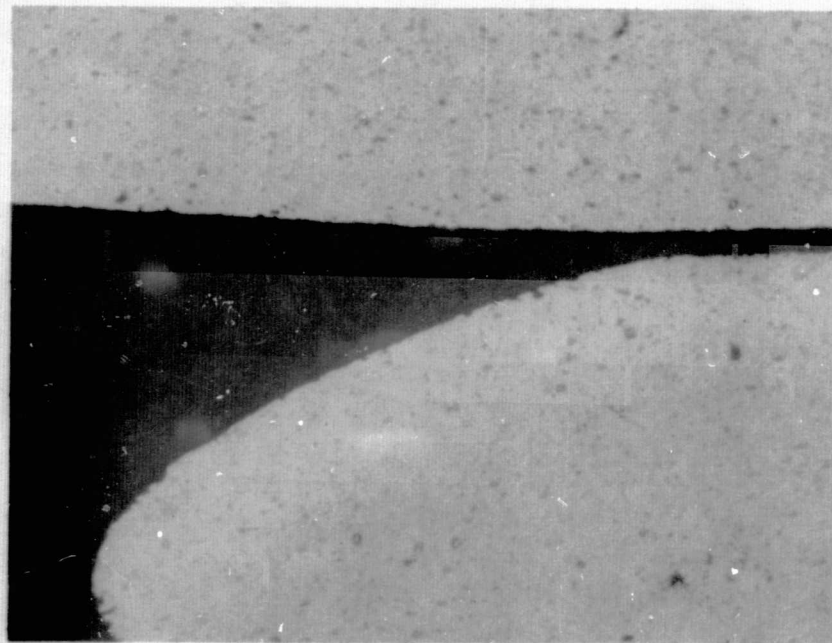
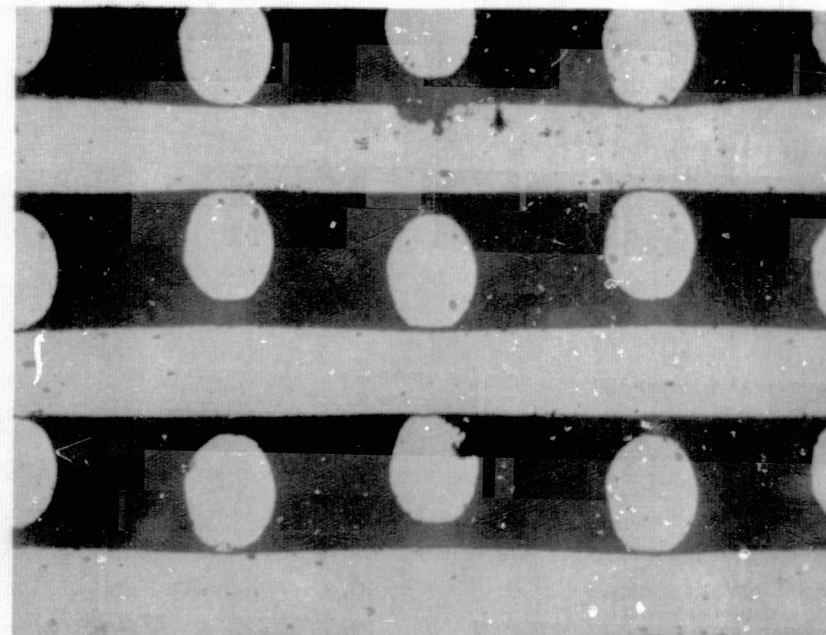
Fig. V-3 Aluminum Screen after Exposure to N_2O_4 for 600 Hours at $135^\circ C$ (200x)

6061 Aluminum Screen Anodized with Chromic Acid - No observable attack was found. Anodic coating was intact. See Fig. V-3 for a microsection of this specimen.

Note: The chromic acid anodized specimen sustained no attack.

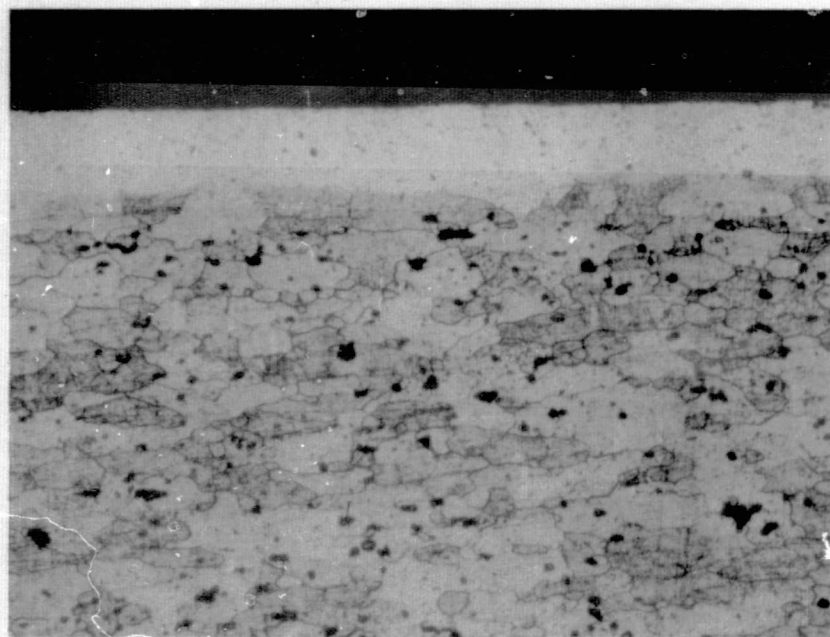
Fig. V-4 Aluminum (2024-T3) Clad with Pure Aluminum after Exposure to N_2O_4 for 600 Hours at 135°C (200x)

Note: Surface is free of pits; there was no penetration of the clad coating

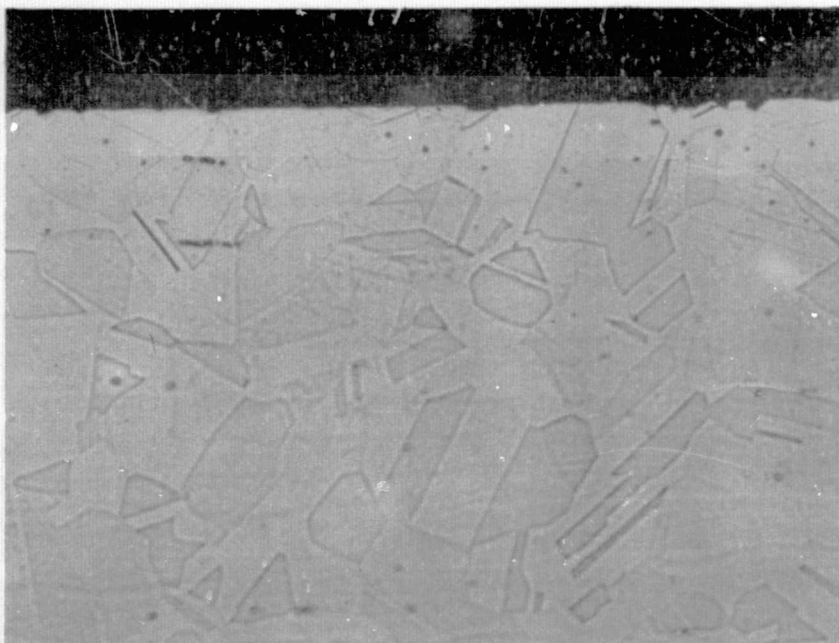
Fig. V-5 430 Stainless Steel Passivated Surface

430 Stainless Steel - This alloy sustained a minor degree of attack that resulted in superficial darkening of the specimen surface. There was no formation of any of the viscous corrosion product or of intergranular corrosion that was typical of the 300 series alloys. The surface darkening was primarily found in areas that were freshly sheared or had recently been shot peened. Since the specimen had been passivated before specimen preparation, and not after, this indicates that the specimen was more active in the freshly worked areas. Photomicrographs were taken of a passivated surface (Fig. V-5) and a shot peened surface (Fig. V-6). As may be seen, no observable chemical attack existed on either area. The rougher appearance of Fig. V-6 is the result of the shot peening. This alloy may, for all practical purposes, be considered inert to the propellant sterilization environment.

Note: There was no evidence of intergranular attack or pitting in either photograph. Surface roughness shown in Fig. V-6 was the result of shot peening.

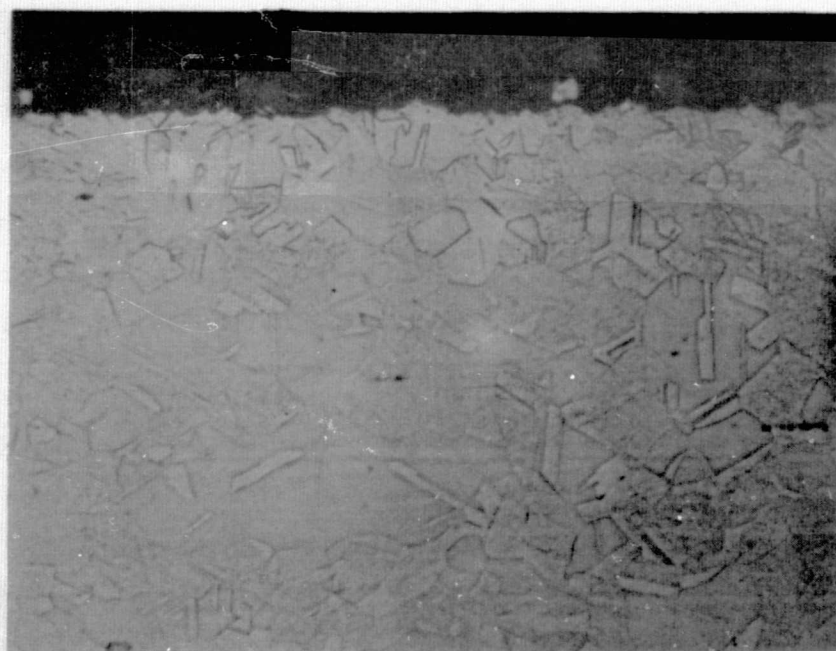
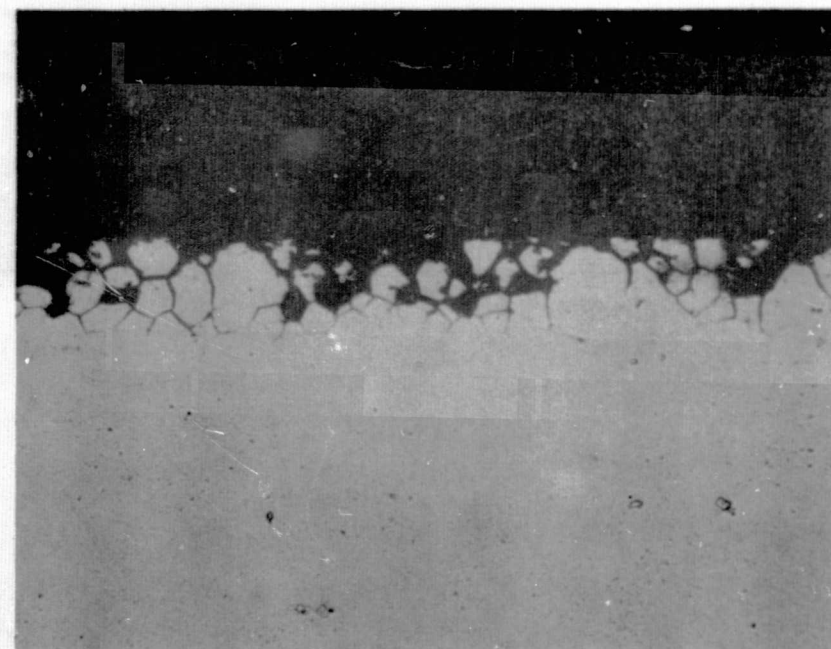
321 Stainless Steel, Chromium Plated - A light attack was sustained with resultant formation of a minute amount of viscous corrosion product. The amount of the product formed was less than 1% of that formed when bare 321 stainless steel was exposed to N_2O_4 during the sterilization cycle. Ordinarily, chromium plating is a poor protective coating against corrosion because of microscopic porosity inherent to this coating. This porosity apparently allowed the small degree of attack to take place. There are proprietary processes available which produce a crack-free chromium plating. Application of this type of coating could be of significant value in protecting the 300 series stainless steel alloys. Figure V-7 illustrates the degree of protection provided by the standard plating process.

Note: The chrome plated specimen was not attacked. The plating is shown as a dark surface in Fig. V-7 (a).

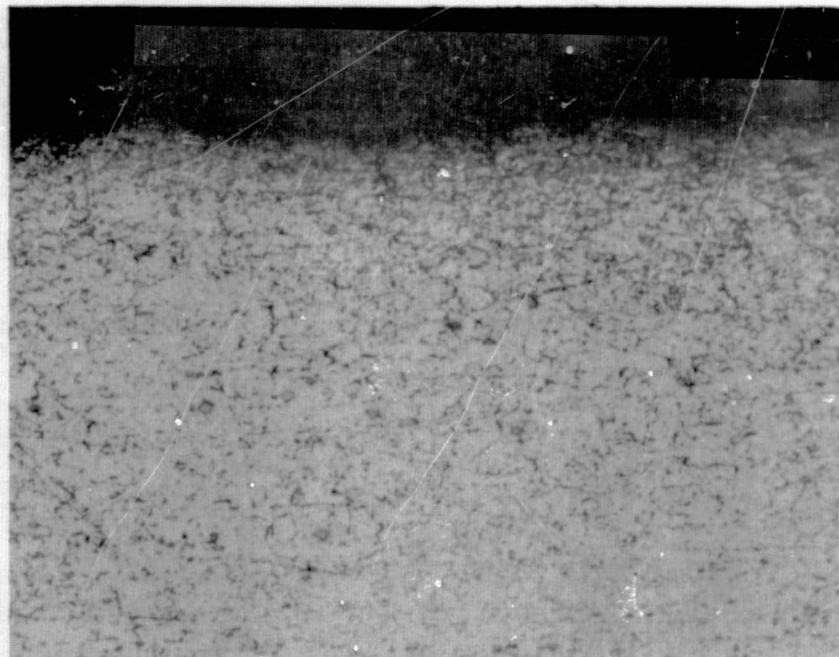
Fig. V-8 Stainless Steel (AMS 5538) after Exposure to N_2O_4 for 600 Hours at 135°C (200x)

Note: Surface attack is evidenced by small pits. No significant intergranular attack is apparent.

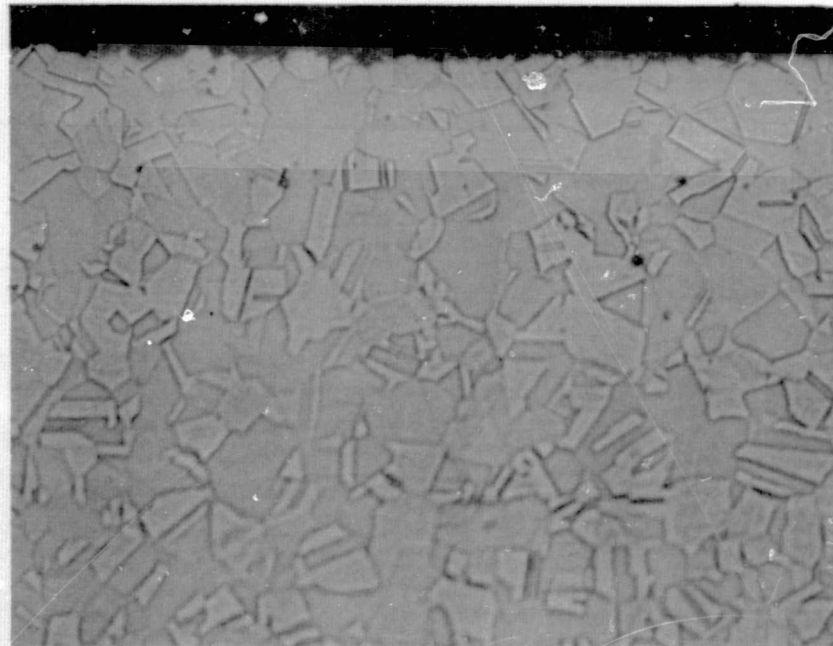
Fig. V-9 Stainless Steel (21-6-9) after Exposure to N_2O_4 for 600 Hours at 135°C (200x)

Note: Surface is roughened by pitting. Some intergranular corrosion is observable.
Structural strength not affected.

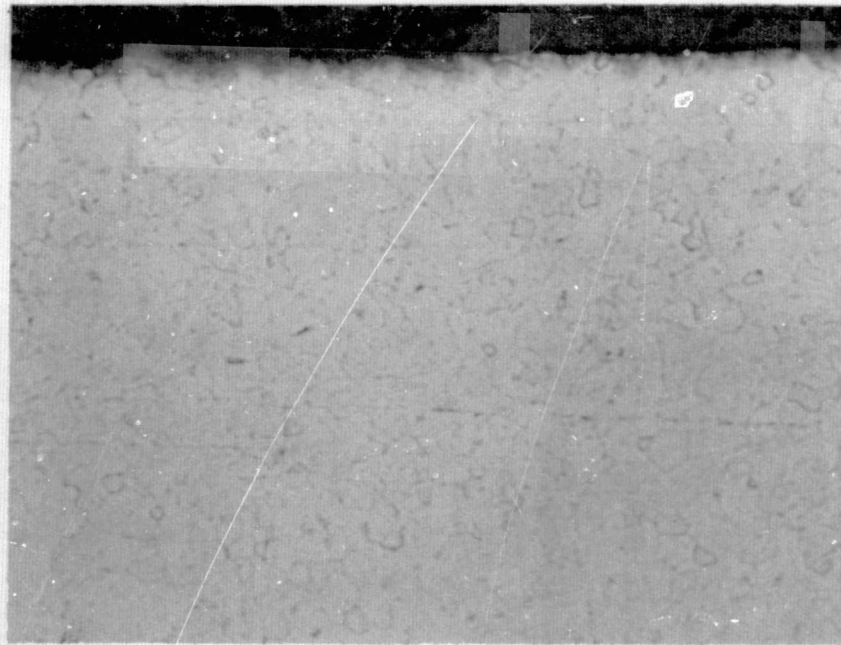
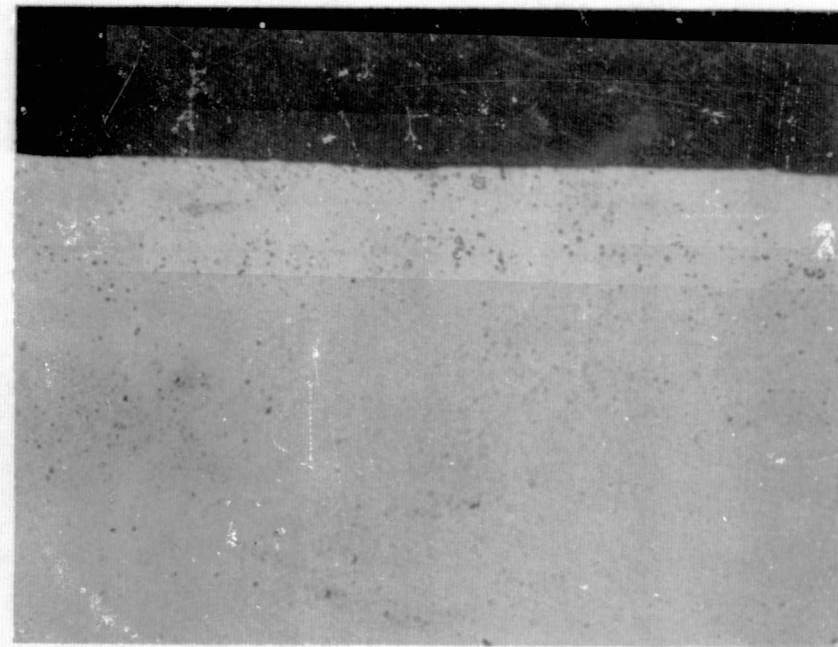
Note: No evidence of attack of either alloy.

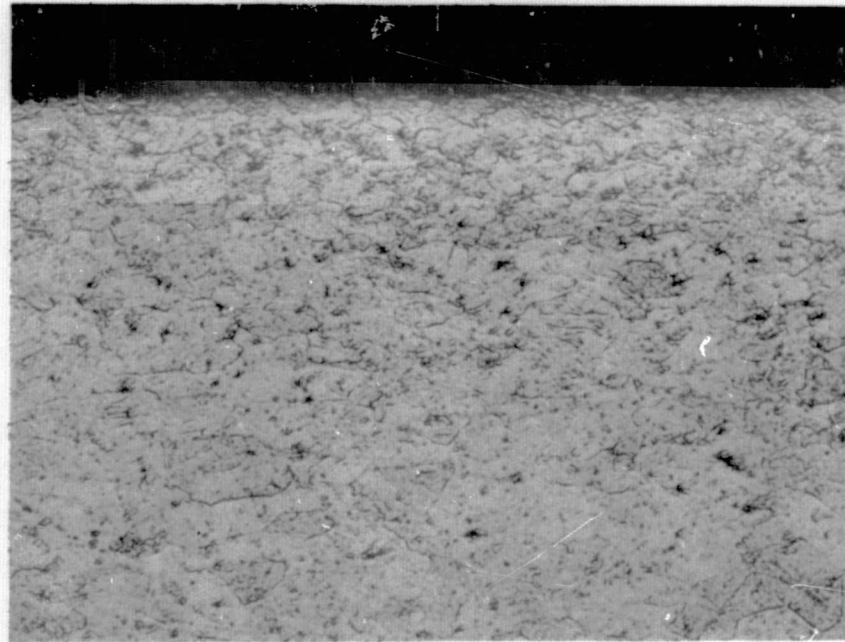
Fig. V-11 Columbium (DP14) after Exposure to N_2O_4 for 600 Hours at 135°C (200x)

Note: No evidence of surface attack or intergranular corrosion observable.
The light attack seen during surface examination was too small to be seen at 200x magnification.

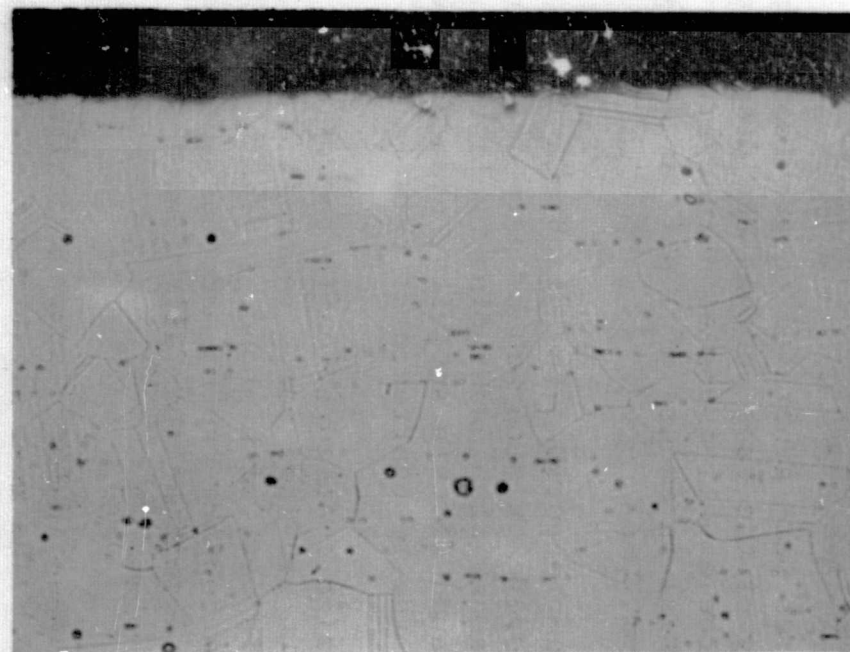
Fig. V-12 Cobalt (L-605) after Exposure to
 N_2O_4 for 600 Hours at 135°C (200x)

Note: Some minute pitting of the surface is in evidence.
No intergranular corrosion occurred.

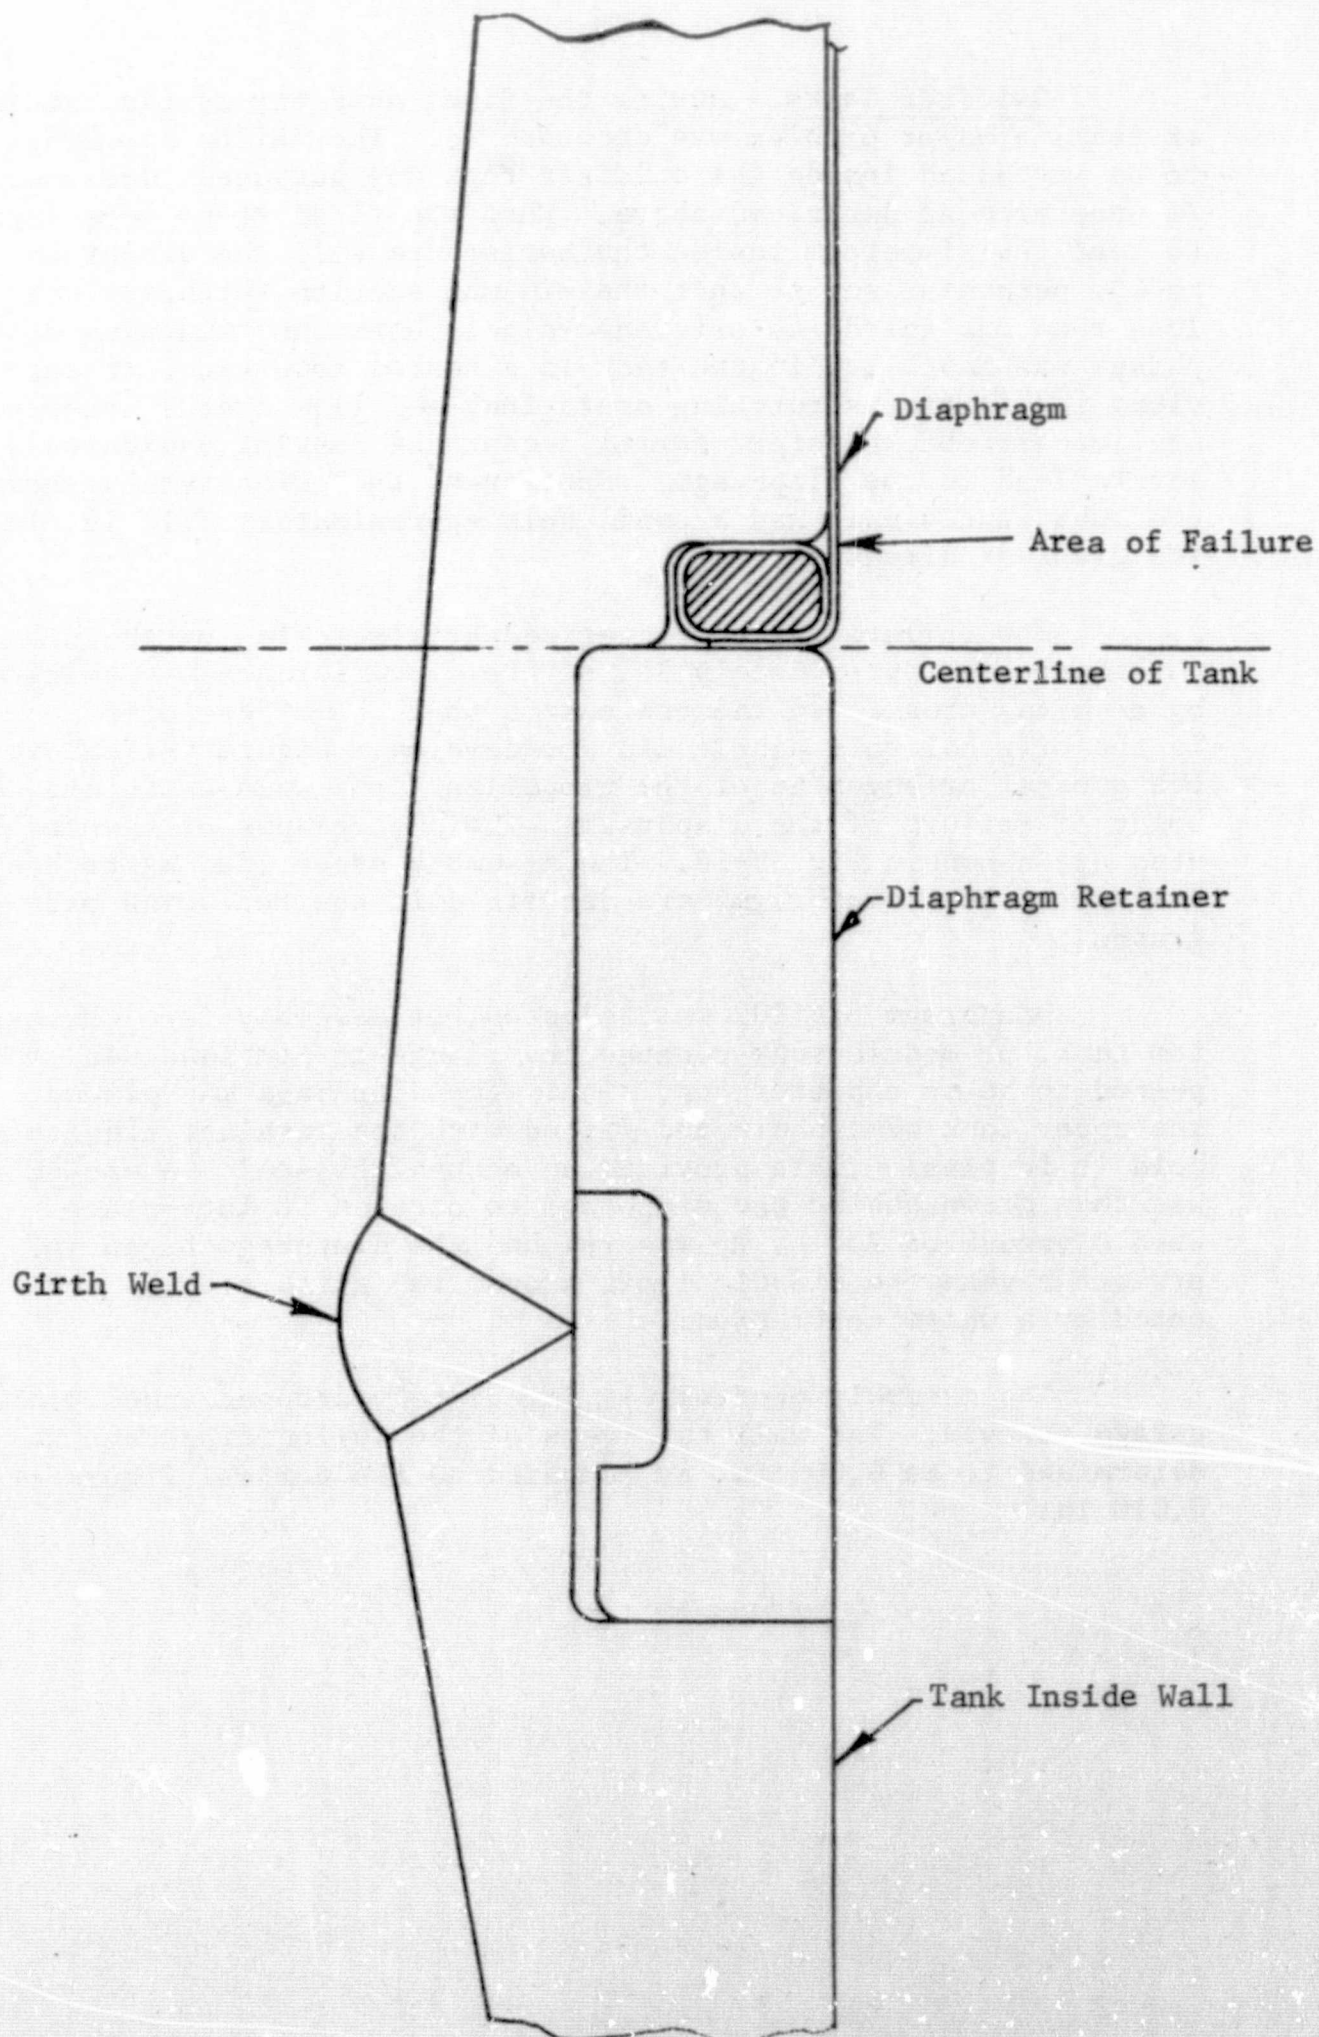
Fig. V-17 Oxidizer Tank Diaphragm Failure

- 7) Failure of one of the diaphragms was attributed to maintaining pressure loads after the diaphragm was stretched in a heated condition. Removal of the heat caused the membrane to exceed the ultimate strength, which led to the failure;

Oxidizer Tanks - During the final assembly of the oxidizer tanks a major problem was encountered. The Teflon diaphragm to be installed inside the oxidizer tank was purposely designed 2% undersize as described above. When the final steps were taken to seat the diaphragm inside the hemisphere wall the diaphragm took a permanent set so that the minimum section thickness was less than one-third its original value. When the remaining diaphragm was installed in the tank in a heated condition, it survived the initial stretching operations and leak check; however, preliminary checks before formal acceptance testing indicated a severe leak in the diaphragm. Subsequent tank disassembly showed the substituted unit had a small hole approximately 1/16 in. in its greatest dimension.

Diaphragm S/N 102 was selected for assembly into the system tank, or module tank because the flange-to-membrane seal appeared to be in a better condition. The diaphragm was placed in the upper tank hemisphere and fitted with the retainer ring to hold it in place. This provided a vacuumtight seal. A vacuum was then drawn behind the diaphragm to stretch it into place. When a vacuum of 20 in. Hg was reached the diaphragm began to stretch beyond the elastic limit around the girth area as indicated by a white coloration.

The assembly process was immediately stopped and the diaphragm removed. The wall thickness of the Teflon diaphragm was determined to be 0.003 in. as compared to the nominal figure of 0.010 in.

A conference was held with the diaphragm vendor, Dilectrix Corporation of Farmingdale, N. Y. During that conference it was suggested that the remaining diaphragm be heated in the upper dome area of the diaphragm to induce a uniform stretch into the tank hemisphere. The vendor's experience with this type of a diaphragm configuration indicated that a stretch up to 4% at room temperature had been obtained. With this knowledge plus the application of heat to the tank wall there was every reason to believe the second diaphragm, S/N 101, would be satisfactory. The diaphragm and tank walls were heated with a hot air gun to approximately 160 to 180°F. The lower half was then assembled and clamped into position. Sufficient force was applied to draw the tank halves to a gap distance of 0.010 in. for welding.

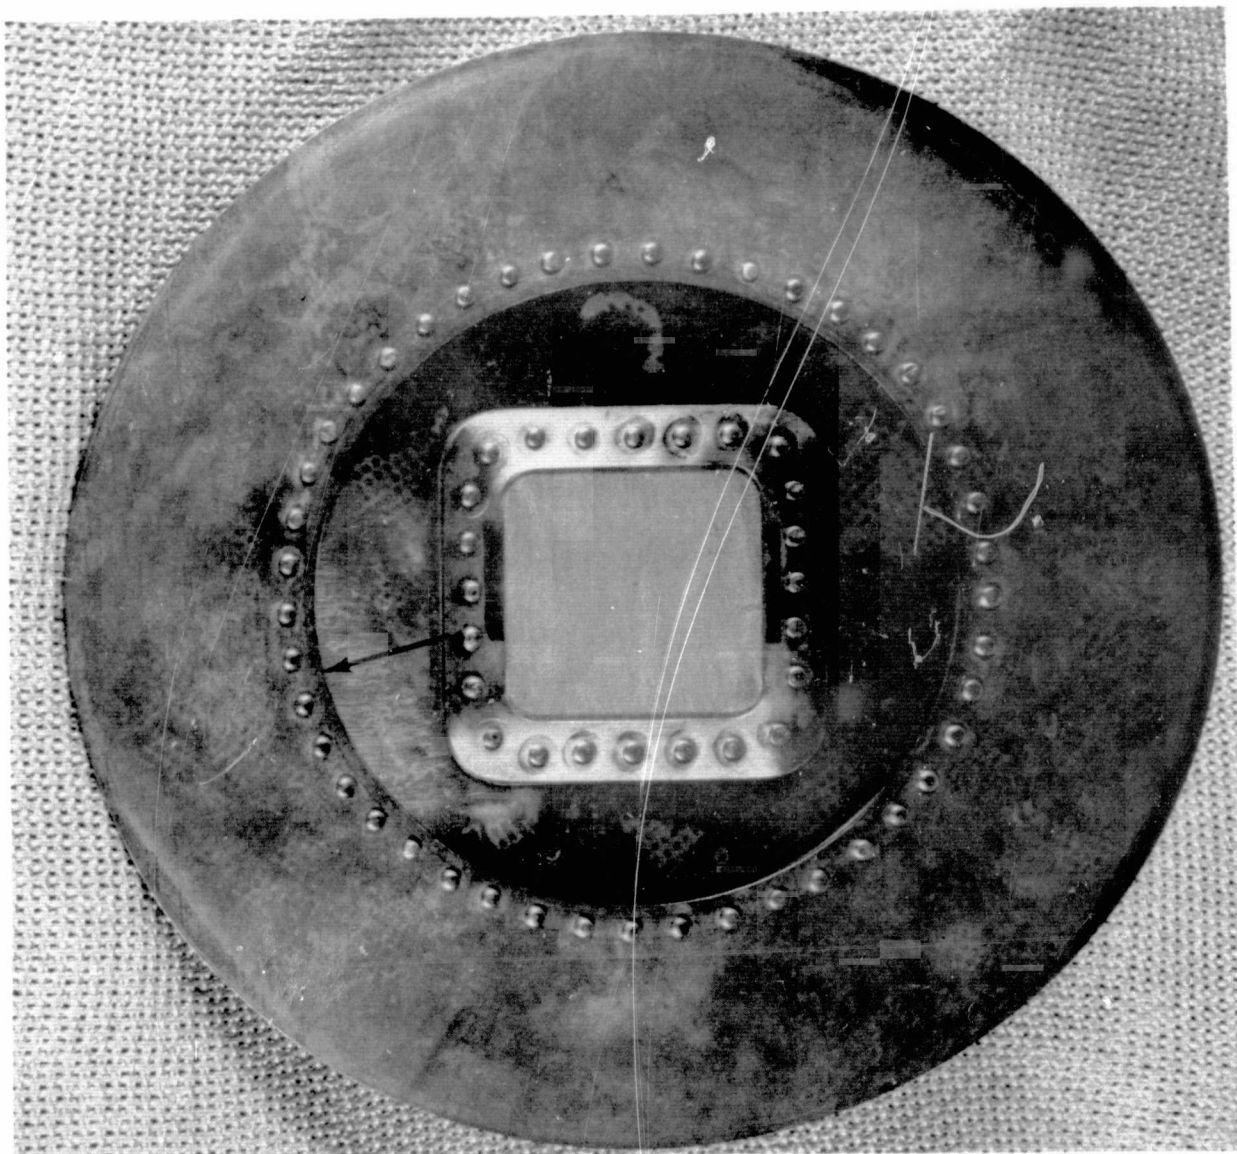
Fig. V-19 Typical Trap Assembly Showing Leak Path

Earlier investigations of the dimensional configurations, leakage, and computed pressure drops were also fruitful. Leak check data revealed the trap in the component propellant tank broke down at 1.5 in. H₂O. This leakage was through the rivet holes at the bottom of the trap. Careful examination and measurement of the as-built condition revealed that the clearances between the shoulder of the trap and the tank wall would develop a pressure drop in excess of 1.5 in. H₂O at system rated flow. Figure V-20 shows the trap installation into the propellant tank.

A parallel effort was started that would lead to the proper design changes for the trap and rebuild schedule for the fuel tank assembly. The trap was modified to eliminate the rivets at the bottom of the trap and provide a greater flow clearance at the shoulder of the trap. This reduced the flow pressure drop in this area to 0.127 in. H₂O and further eliminated the potential leak path through the rivet holes.

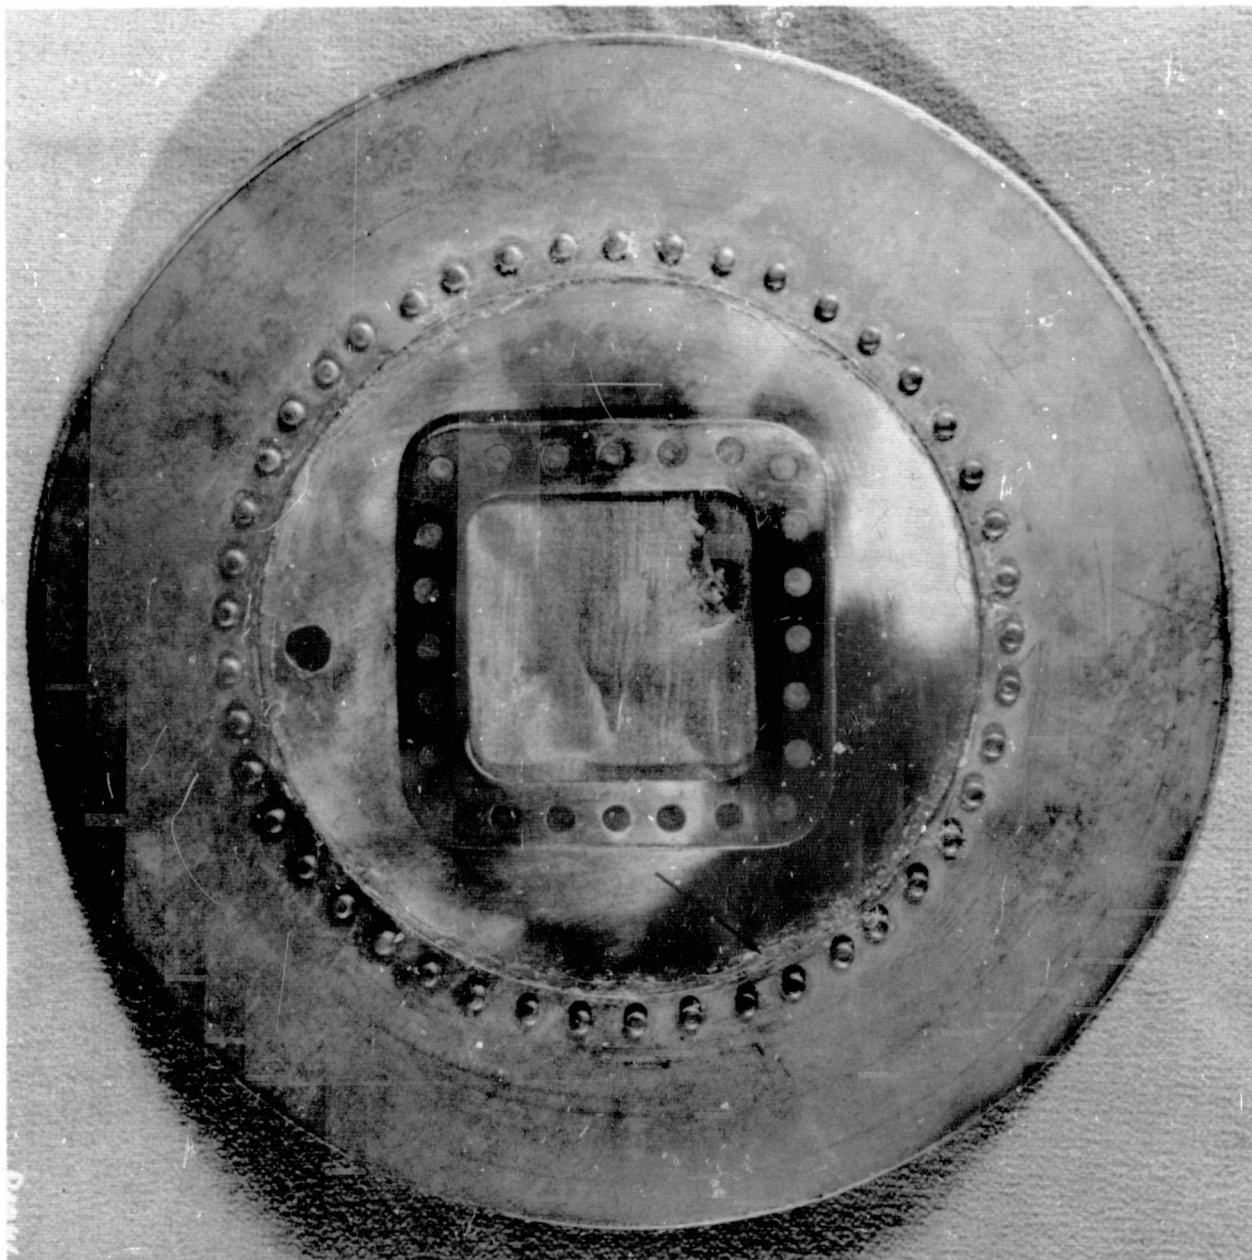
Fig. V-22 Fuel Trap Assembly Showing Water Glass Seal After Test

To assure that the available trap assembly from the component tank could be properly treated and tested with the water glass, a demonstration was performed. The questionable joint was cleaned with an alkaline solution and water rinsed. Upon air drying methyl ethyl ketone was swabbed around the joint and dried. The water glass was then applied and allowed to dry for 48 hr (see Fig. V-22). The unit was then assembled into the hemisphere and water flow tests proved conclusively the leak between the riveted plates had been stopped as indicated by single-phase liquid flow. These procedures were employed on the trap installed in the modified tank before the final closure weld.

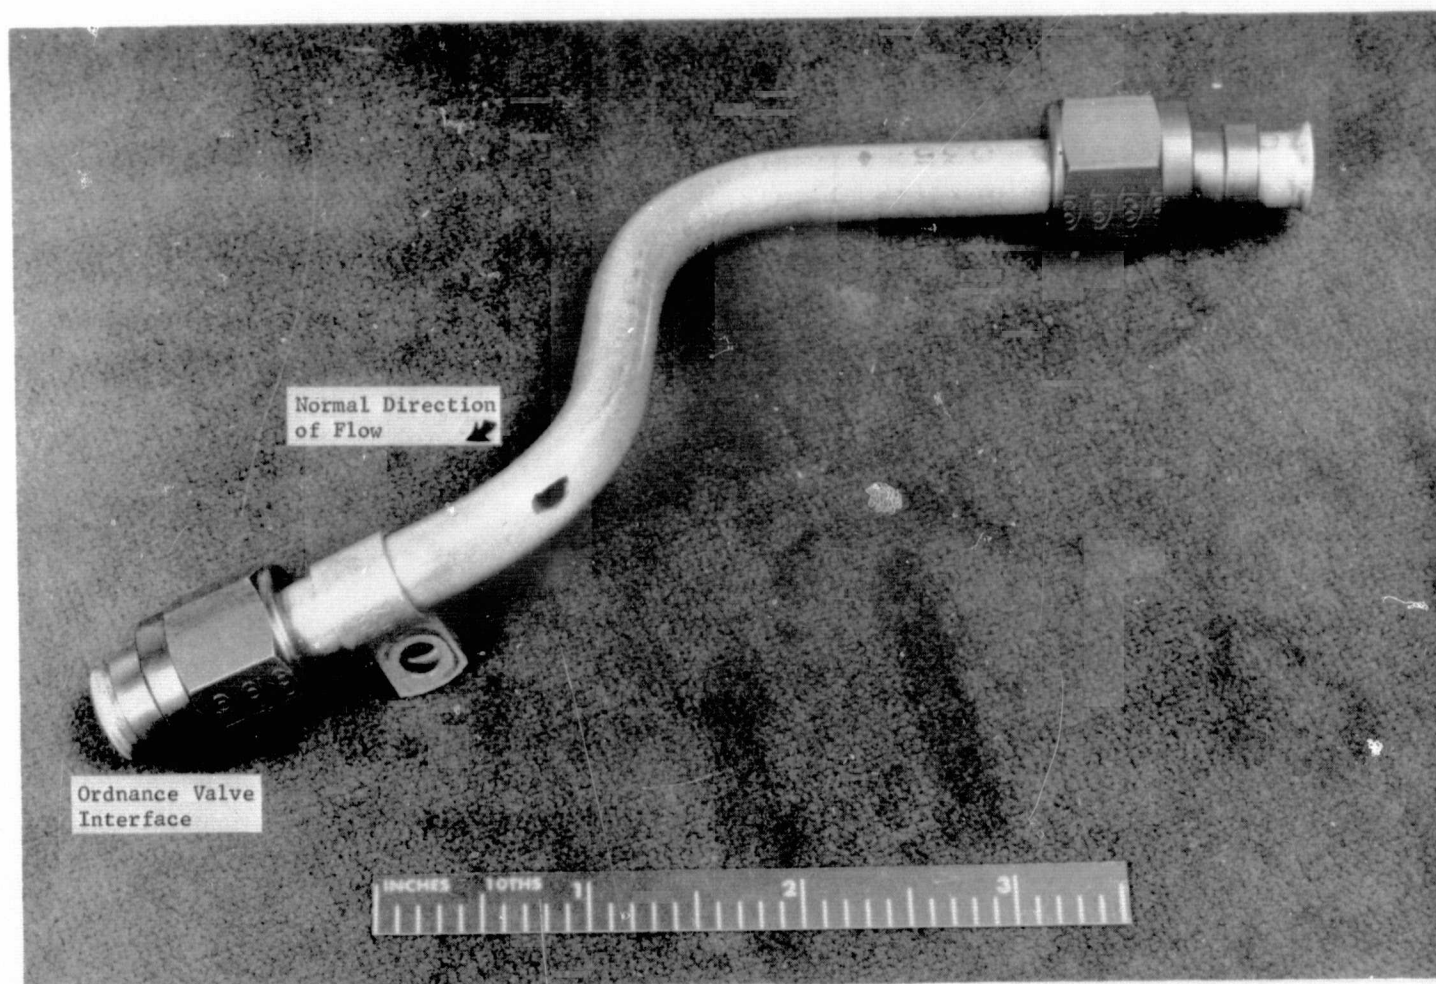
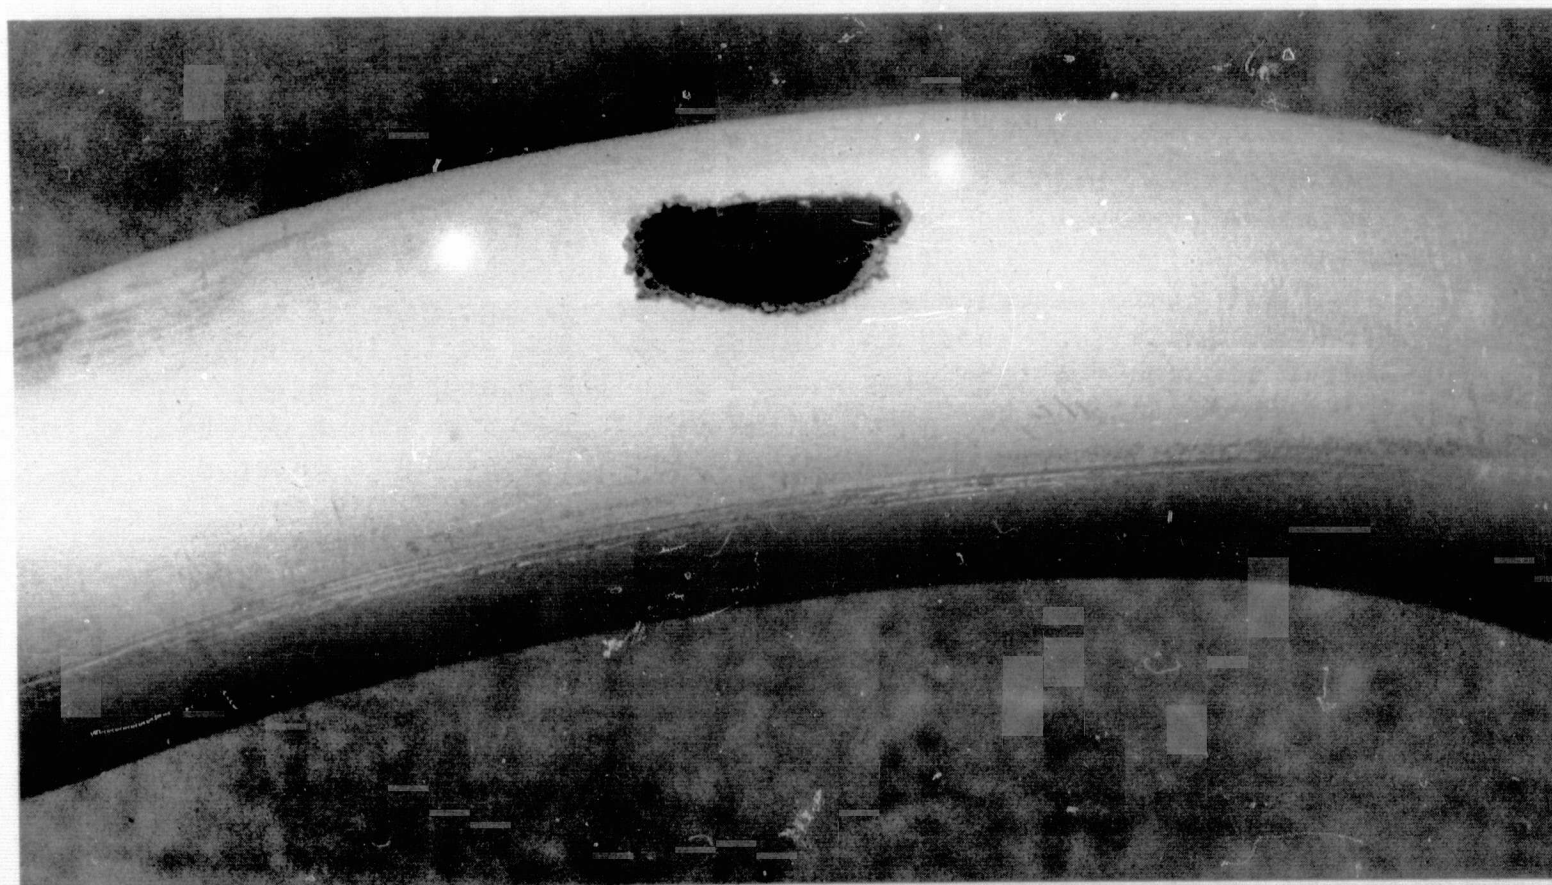
- 1) The cause of the aborted firing attempt was the improper assembly of an ordnance valve. This allowed burning combustion products and melted aluminum to enter the system tubing, which led to a tube failure at a bend in the tube;

Investigation and examination of the module revealed the pressurization line just upstream of the ordnance valve, EXV-3, had a sizable hole in it. Figures V-27 and V-28 show a close up of this line and failure.

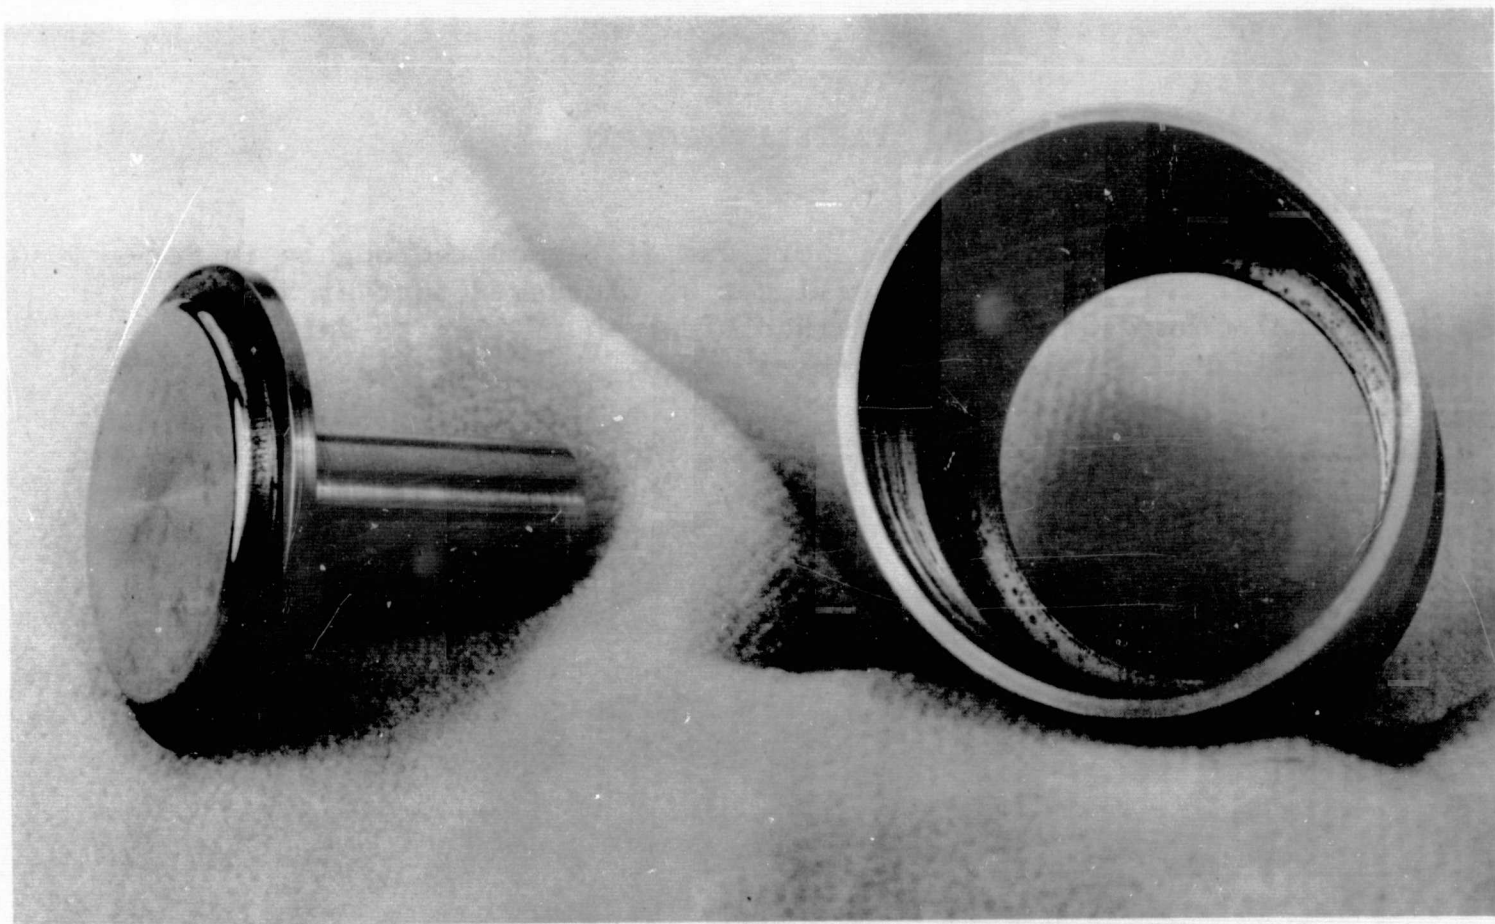
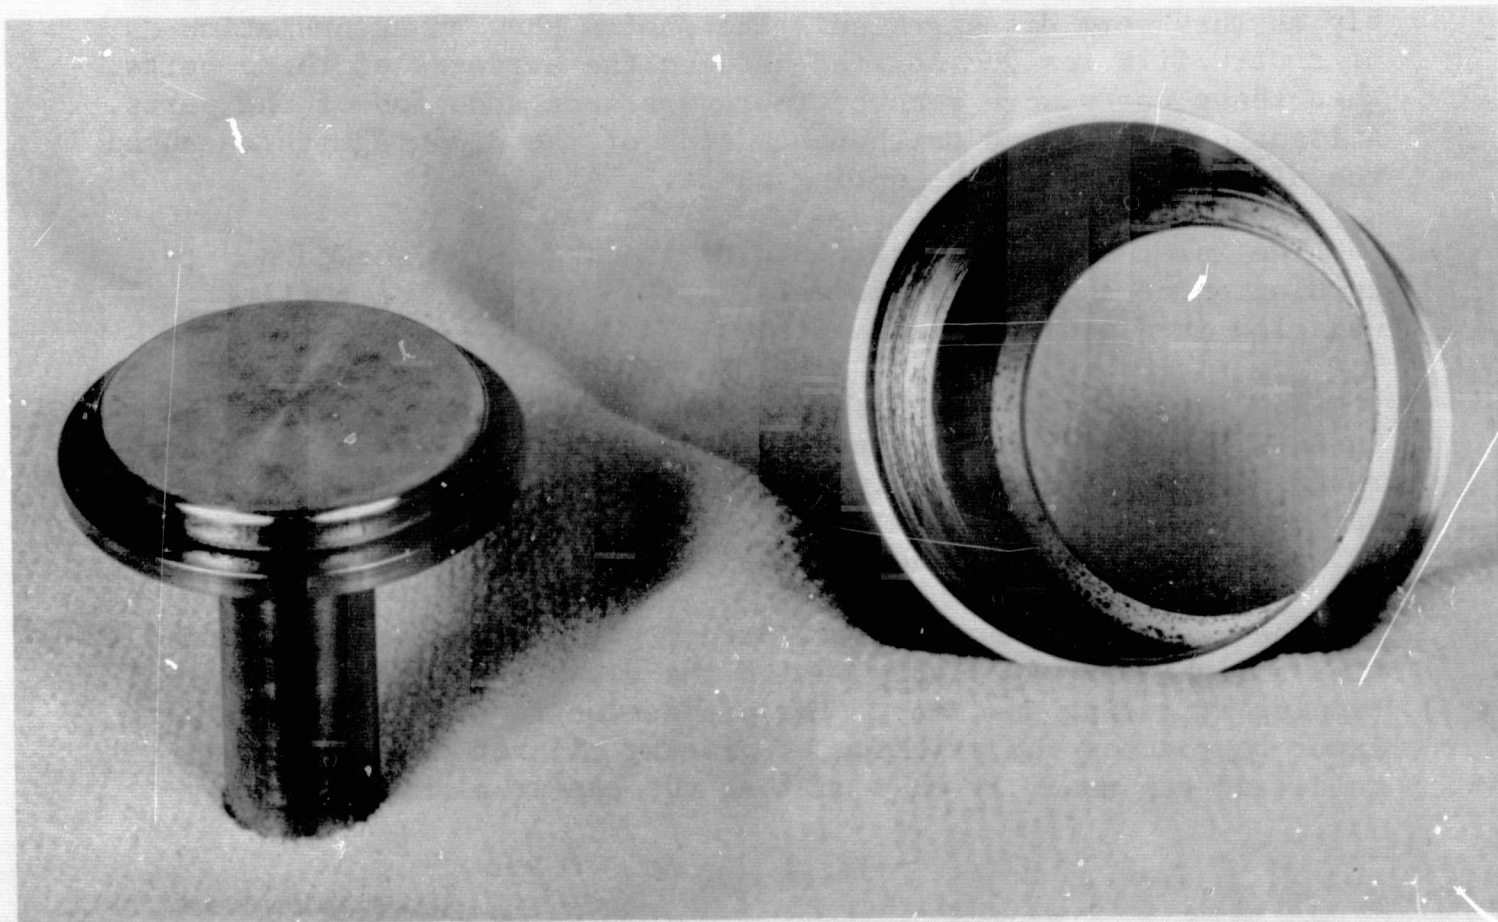
Fig. V-33 Regulator Spring Guide and Cap Assembly

- 2) The remaining system components and the Marquardt engine operated satisfactorily following the second sterilization exposure;
- 3) The regulator was stuck in the open position after storage of 15 months following the initial system firing demonstration. This malfunction would have seriously jeopardized a planetary mission. The cause was attributed to a coagulated lubricating film in the area of the spring guide and cap assembly. This problem can be solved with no new technology;

- 7) The regulator failure mode should be eliminated by knurling the contact surfaces or providing contact lands to reduce the surface area to prevent the sticking. Additional tests should be performed to verify the corrective action;

The suggested corrective action is either to knurl these surfaces or machine lands in the cap assembly to reduce the finely machined contact area.
